## **Man Overboard Lesson Learned**

# Lesson Learned

## “Man Overboard”

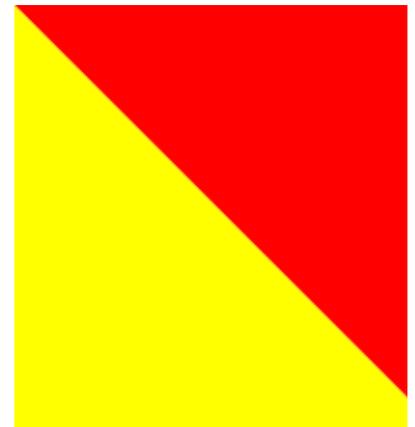
Figure 1 – Oscar flag indicates MOB.

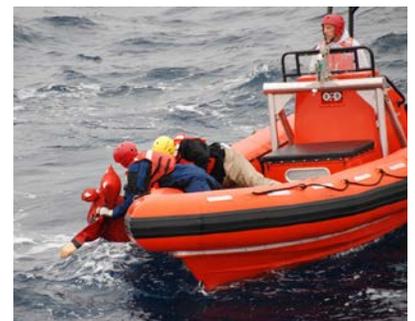
Figure 3 – MOB recovery during a drill.
